CABLE PROTECTION METHODOLOGY AT SURF ZONE IN MALDIVES

Naoki Maekawa, Mikinori Niino, Yutaka Kiuchi (NEC Corporation)

Abstract: NEC was contracted for the turn-key supply of a submarine cable system for a customer in the island nation of the Maldives. This paper describes the cable protection methods used in the completion of the cable system, which would be useful for future projects in similar environments.

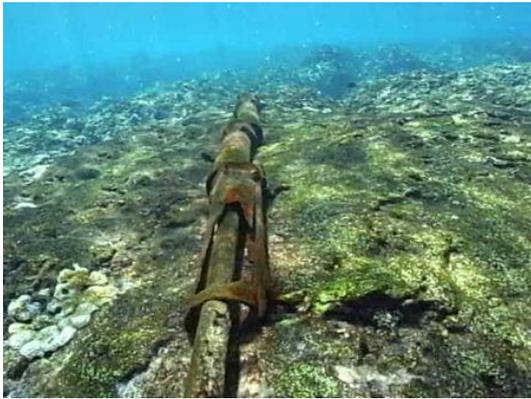
Upon the past project, we experienced that Articulated Pipe was continuously moved by the wave action especially within surf zone and the movement of Articulated pipe cause the abrasion between the seabed then gradually wear the wall of the pipe. Finally articulated pipe was broken and removed from the cable. In addition, one piece of Articulated pipe was removed, a neighbouring one would also be removed as like a chain reaction.

Photo-1 Damaged Articulated Pipe

The countermeasure against abrasion which can not avoid with clamps of 10m intervals was to change the material of Articulated Pipe from the cast iron to Polyurethane.

Polyurethane is unbreakable elastomer. It is expected that Polyurethane Duct provides the higher protection performance against abrasion and impact compared with cast iron pipe.

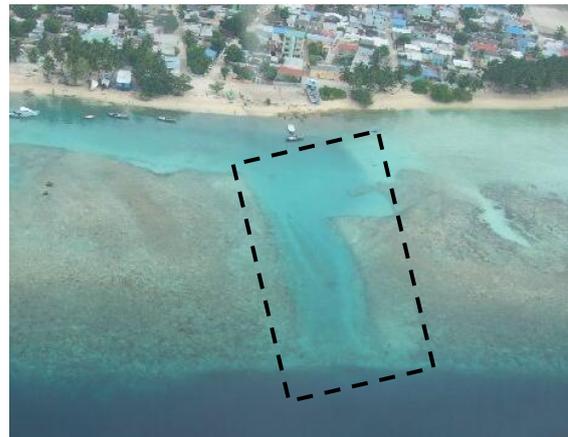
However the environmental massive damage of breaking coral reef was not acceptable for the authority. Therefore this methodology also could not be applied for the project.

Photo-2 Reef Cut

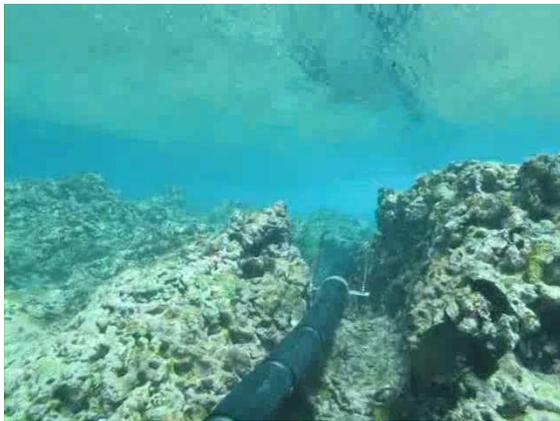
During installation, Clamping team faced several difficulties to do the work due to seabed undulation and soft seabed feature consisted from live and dead coral reefs which do not have adequate hardness to hold the anchor bolts of the clamps. It was required to adjust the clamp location to install relatively harder seabed in around. The natural trenches were observed along or across the cable route. In case it was possible to move the cable by the diver, cable was put into the trench as much as possible and clamped in the natural trench to reduce the potential movement.

Photo-4 Polyurethane Duct and Clamp in Natural Trench
