## LAYING IT ON THE LINE AT BOTH ENDS OF THE WORLD

Mark Jonkergouw & Sasha O’Bow-Hove (Alcatel-Lucent Submarine Networks)  
[mark.jonkergouw@alcatel-lucent.com](mailto:mark.jonkergouw@alcatel-lucent.com) , [sasha.obow-hove@alcatel-lucent.com](mailto:sasha.obow-hove@alcatel-lucent.com)

**Abstract:** This paper discusses how Alcatel-Lucent Submarine Networks (ASN) addressed some specific marine installation challenges in the Southern and Northern hemispheres, where identifying, planning for, managing and minimising the many and varied risk factors was vital for the success of the cable installations. The ultimate aim on all projects is of course to install the cable within its design parameters and to the Customer’s requirements, and the variety and severity of potential risks can be greater on the shorter, shallower water projects. To achieve the optimum installation, even after good risk identification, mitigation and thorough preparation, can still demand “on the job” flexibility and creativity, to adjust the operations as necessary to cope with unforeseen issues, as will be shown in this paper.

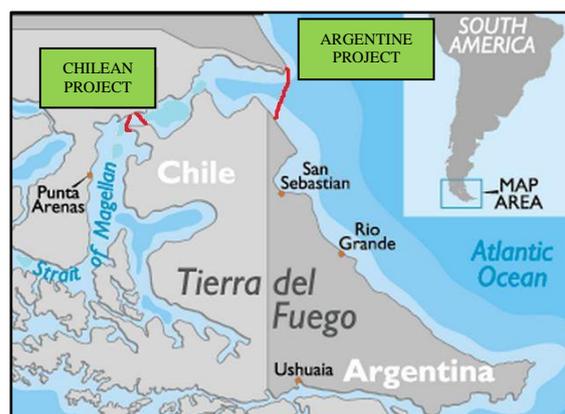
Figure A: The Three Cable Routes (in red)

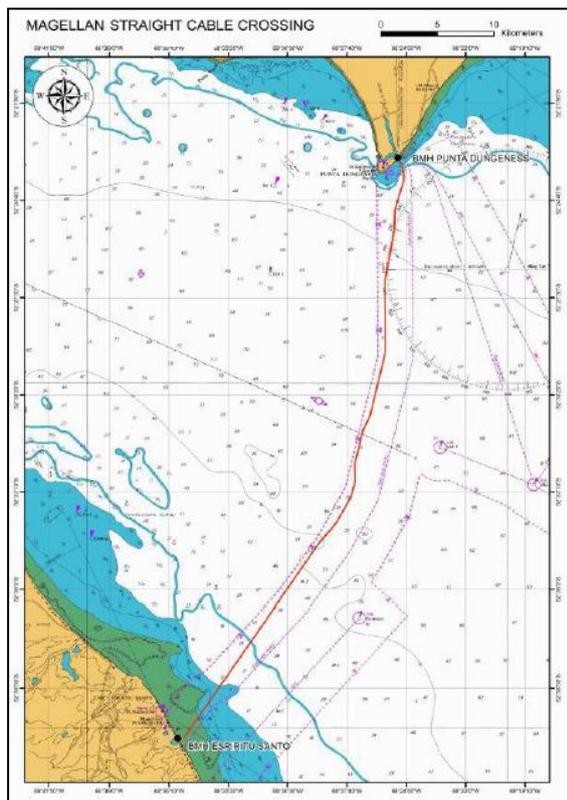
The Argentinean cable project consisted of a single 35km unrepeated cable connecting Punta Dungeness on the northern mainland to Espiritu Santo on Tierra del Fuego.

**Figure B:** The Argentinean Cable Route (in red)

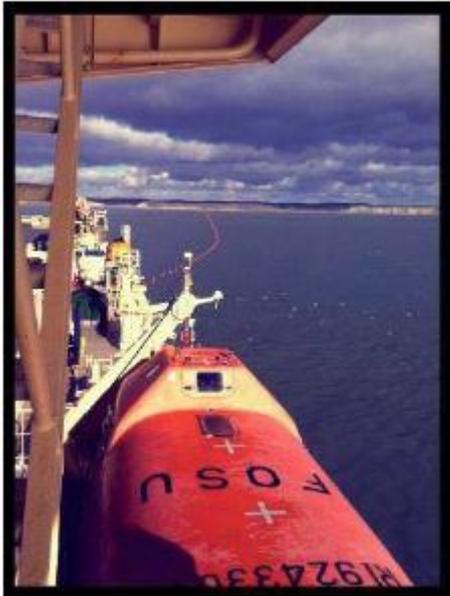
The installation strategy for the system was for a double armoured cable plough buried to 1.5m target depth. In addition, at the Espiritu Santo shore-end, 2m burial depth to the 20m water depth (LAT) was required, and this had to lie within a 10m wide by 2m deep “dredged trench” that had been backfilled with sediments. From a cable protection point of view, the rationale to dredge a 2m deep trench through the locally hard seabed and backfill it with softer sediments made good sense, as it would optimise the cable burial potential. However, from a shore-end installation point of view, having to make sure the cable was laid into such a narrow

channel would make the whole operation considerably more difficult than normal! This was even more so when considering that this location has a 9m tidal range and 2-3 knots of current at peak tidal flows. In addition, the shallow seabed slope meant the 20m depth contour was 6.5km offshore, so floating and accurately lowering such a long section of cable to the seabed along the dredged channel line was a major concern and installation risk factor.

To achieve success the strategy was to maximize the use of the cables ship and minimise the cable pulling and diver burial distances. This meant taking the cables ship to a holding position in only 10m (LAT) water depth, while normally the standard holding position would be at 12m-15m water depth (the cables ship draft is 8.5m). This resulted in a 3km shore-end pull, which although much shorter than 6.5km, was still the longest cable-pull performed by ASN in such a dynamic tidal and climatic area. With the cable landed ashore, the cables ship waited for high tide and then moved further shorewards to the 8m water depth (LAT), at 2.8km from the beach, and starting plough burial there. In essence, by using the huge tidal range, even with the plough-down location at 8m depth LAT, the real water depth at plough deployment time was 15m, this being the minimum limit of safe plough deployment for our vessels (any shallower and the ship’s hull could strike the top of the plough). The 2m burial was achieved by the cables ship in the offshore shore-end section (from KP2.8 to KP6.5), with diver burial shoreward. By using divers only in the shallow areas, the diving safety was also maximised, which is even more important than usual due to the remoteness of this area.

**Figure C:** 3km shore-end pull at Espiritu Santo

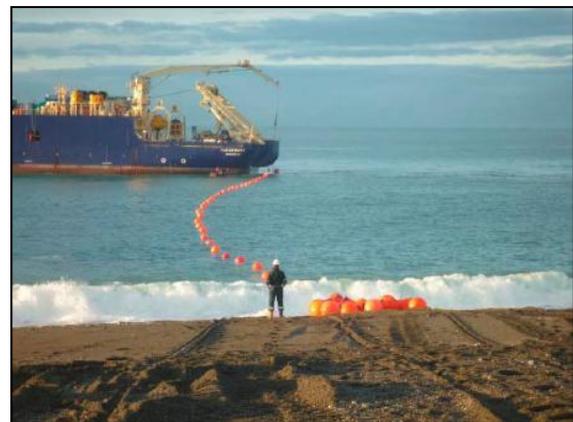
For Punta Dungeness, at the northern end of the cable lay, the shore-end landing challenges were nearly the reverse of those at Espiritu Santo. Here the choice of landing location was very limited, as the BMH had to be located between the Chilean border, only a few hundred metres to the west, and a Penguin Nature Reserve, only a few hundred metres to the East. In effect, there was no choice in landing location, and so the steeply shelving spit that forms Punta Dungeness had to be used. The major concern for this landing was the strong tidal flows, because the spit forms a barrier to the tidal currents that flow in and out of the Magellan Strait. As a result, right at the landing location the tidal currents are greatly accelerated, increasing the demands on the cable ship for holding position. In addition, the predominant south westerly wind is blowing in a landward direction here, trying to push the ship onto the Punta Dungeness beach itself. With these factors at play, it was some blessing that the actual distance for the shore-end cable pull would only be short, as the steeply shelving seabed meant the 15m depth contour was only 350m from shore.

As it turned out, on the day of the Punta Dungeness shore-end landing a relatively rare event occurred, as the near constant gale force winds that dominate this region relented and allowed the landing to be performed in perfectly calm conditions, with the cable ship only 210m from the beach – one of the shortest cable pulls in our history. This was certainly proof that even with all the planning in the world, sometimes it also helps for a bit of luck to be your side!

**Figure D:** 210m shore-end pull at Punta Dungeness

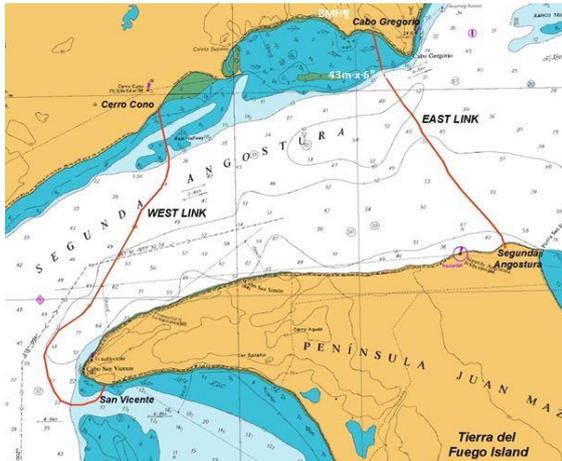
The two unrepeated cables installed in the Chilean part of the Magellan Strait were 12km long (Cabo Gregorio to Segunda Angostura), and 18km long (Cerro Cono to Cabo San Vicente). They were both laid across the “2<sup>nd</sup> Narrows” of the Magellan Strait, which is situated 60km east from the port of Punta Arenas, in the eastern sector of the Strait. While initially planned for plough burial, the lack of sediments in this area meant they were both surface laid onto the seabed.

**Figure E:** The Two Chilean Routes

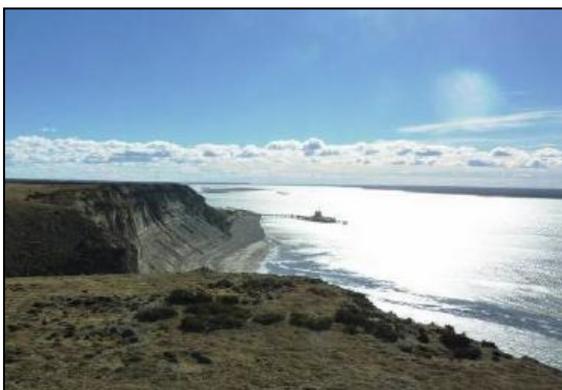
**Figure F:** The Cliffs along the Magellan Straits

The choice of routing across these 2<sup>nd</sup> Narrows, instead of crossing the wider and calmer parts of the Strait, was driven by the need to find suitable landfall locations. Along many parts of the Magellan Strait it was not possible to find suitable beach conditions, with correspondingly suitable land access points for linking to the terrestrial back-haul routes. As a result, from 14 sites visited during the site visit activities (by travelling many 100's of miles on unmade roads and rough terrain), only 4 locations were considered suitable to meet the system design and installation requirements.

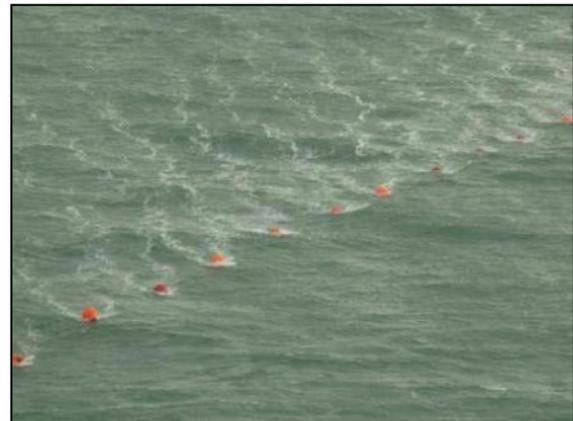
However, for the Cerro Cono landing, due to the long cable pull of 2.4km and the extremely high tidal currents, it was necessary to perform the shore-end landing in two stages. First, the cable was pulled ashore as normal at slack water, but due to the quickly rising currents the cable cut-down activity could not be commenced immediately. With the divers unable to stay in position in the water, the cable tension rising and daylight fading, a decision was made to postpone the cut-down operation until the following day, requiring the cables to hold position overnight as the tidal regime went through an entire cycle. This meant a 2.4km floating cable bight was present between

the cables and the landing for the duration of the night, with tensions rising to 12.2 tonnes at the peak tidal flow (still within the cable design specifications), before eventually easing as daybreak approached the next day. During the short time of slack water, the cable bight was eased back online and the divers performed the cut-down operation as usual, eventually completing the shore-end landing nearly 24hrs after it had started. The high power and dynamic positioning capability of the cables and the skill of the crew meant they were able to maintain full control and positioning to enable the in-specification installation of the cable.

**Figure G:** Floats left on cable for 24hrs landing

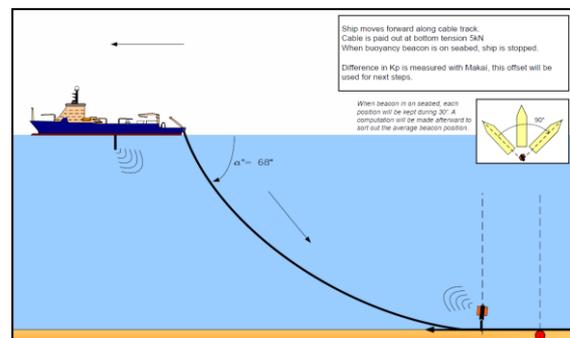
the cable’s touchdown point by the planned cable crossing. A sound velocity profiler (SVP) was first deployed a safe distance away from the crossing, then a buoyancy beacon, in order to assess beacon position accuracy and currents. Then the buoyancy beacon was fitted to the cable at the theoretical crossing position and deployed over the crossing.

Once on the seabed, the beacon’s position was measured at three different cables ship headings to find an average position and best cables ship heading. The offset of the beacon from the theoretical cable crossing position was calculated using the cables ship’s bespoke lay software. The beacon configuration used is shown in Figure 1 and the calibration results in Figure 2 (where the red diamond is the average of the green diamonds at different cables ship headings).

Figure 1: Buoyancy beacon arrangement

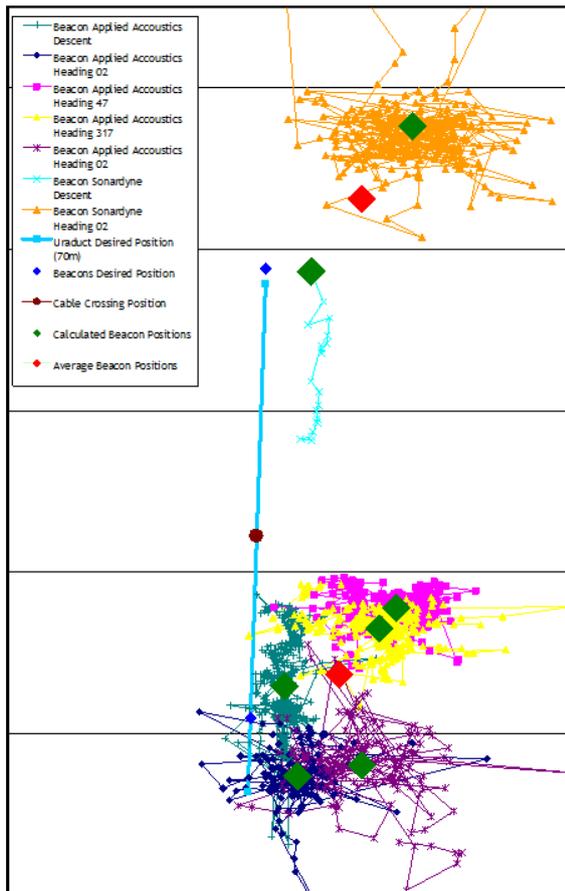
Figure 2: Beacon calibration results

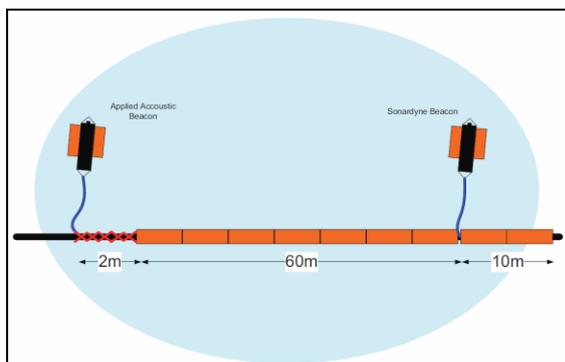
The available plastic protection was then applied to the cable at its predicted touchdown crossing position, with beacons attached for monitoring shipboard, as shown in Figure 3. Two different types of beacon were used to provide better coverage. The outcome was that the plastic protection was laid correctly first time, lying within 10m of target and fully covering the cable crossing, as shown from beacon positions measured shipboard (Figure 4) and later verified by ROV (Figure 5), who recovered the beacons.

Figure 3: Beacon arrangement

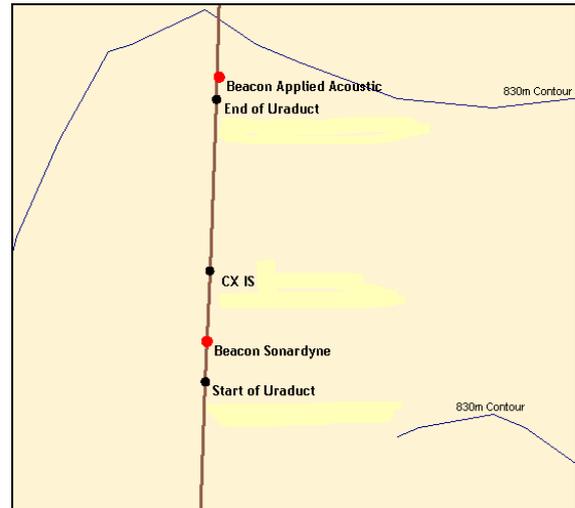
Figure 4: As-laid result

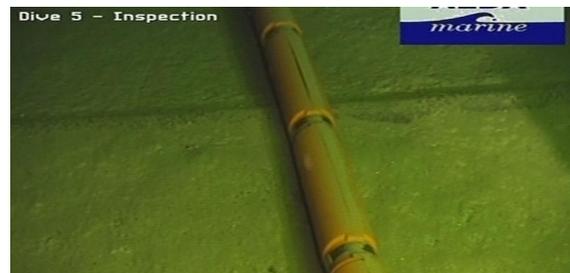
Figure 5: As-surveyed result

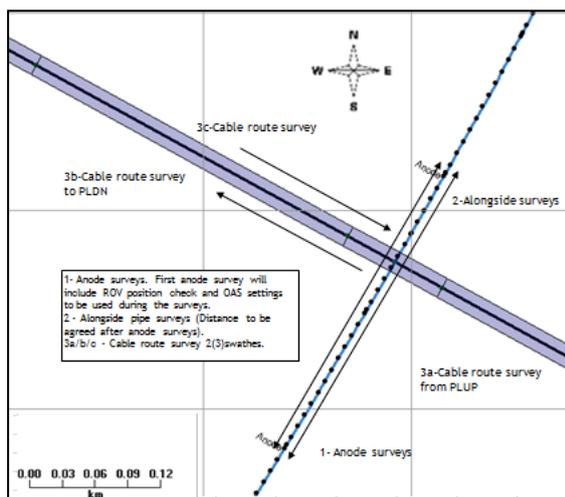
The ROV works included pre-lay survey of the cable route across the pipeline, including the position of the pipeline joints and anodes (to avoid), also the reference anode, to calibrate the relative ROV and pipeline systems. The pipeline survey plan is shown in Figure 6.

Figure 6: Pipeline Survey plan

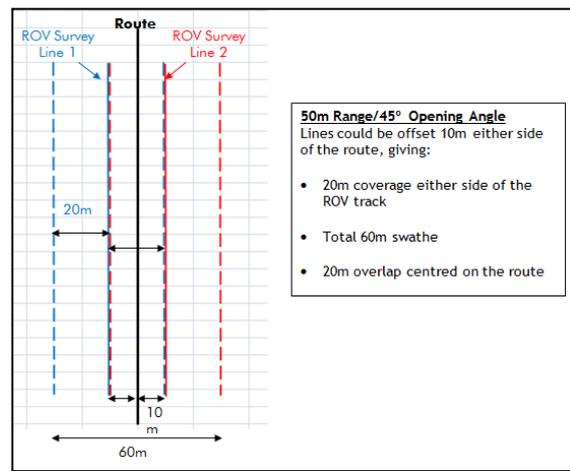
A safe surface lay corridor was established by this contact avoidance process. The survey technique developed and utilised (Figure 7) proved more than adequate.

Figure 7: Safe corridor survey

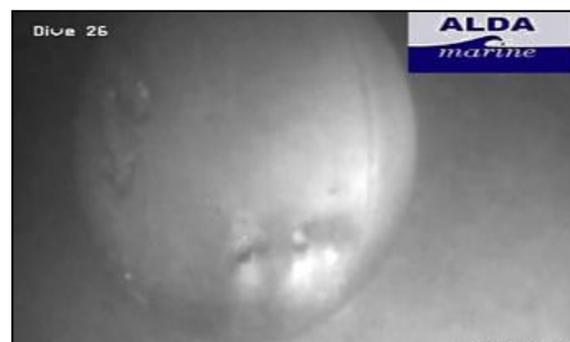
In fact, any munitions detected (Figure 8) were successfully avoided by re-route, using the same proving process.

Figure 8: Example of munitions found
