TESTING OF HIGH RELIABILITY SEALS FOR SUBMERGED EQUIPMENT

Adrian Jarvis, Ian Watson (Huawei Marine Networks Co., Limited)

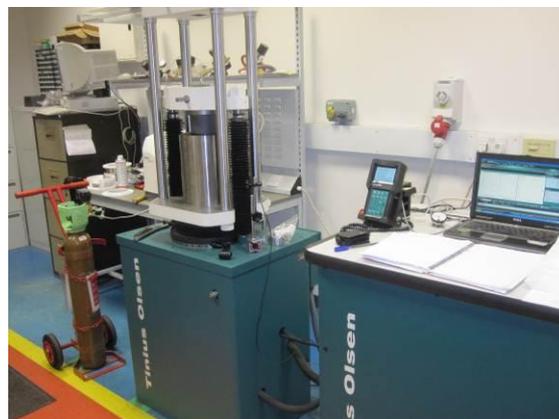
Figure 1: Test equipment including hydraulic press, leak detector, helium source and data logger.

Using the equipment shown in figure 1, the displacement, load and leak rate

characteristics of the seal could be evaluated.

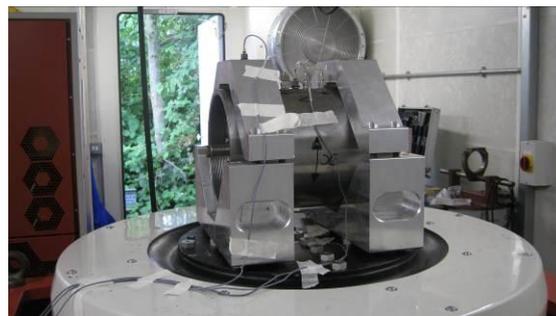
Figure 12: Bump and vibration testing

1. Temperature cycling to +50 to -20°C with 10 hour dwells for 5 cycles.
2. Bump to 50g, 6ms, half sine, 167 times each of 6 directions, total 1000 times.
3. Vibration to 10-150Hz, 5g, 1oct/min, 3 principle axis, 30 min per axis.

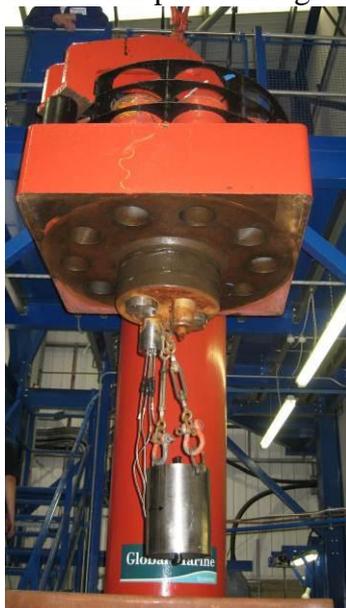
Figure 14: Test sample is attached and connected to the pressure vessel lid

The assembly was attached to the underside of the pressure vessel lid and pipes connected to the ports (See Figure 13), through the lid to the gas supply and leak detector.

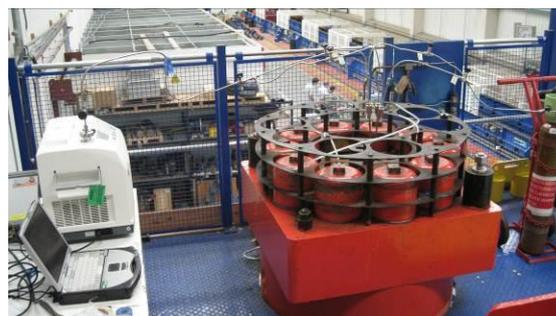
Figure 15: Test sample is connected to the helium leak detector (left) and helium source (right)

The connections allowed the gas to be pressurised with helium at both ends either individually or combined (See Figure 15).

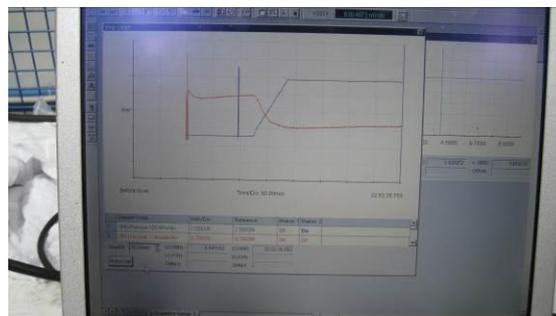
Figure 16: The graph shows pressure increase in blue and corresponding drop in helium leak rate in red

The test began by applying 5MPa of helium to both ends simultaneously and monitoring the combined outputs. The water pressure was increased to 83MPa at a rate of 1MPa/min (See Figure 16 & 17) after which a total combined helium measurement (See Table 3) was taken. The sample was then held at pressure for 8 days.

Figure 16 provides an interesting view of how the application of hydrostatic pressure affects leak performance. This was expected as FEA analysis had shown compressive material movement. This

closing of gaps and voids reduces available leak paths.

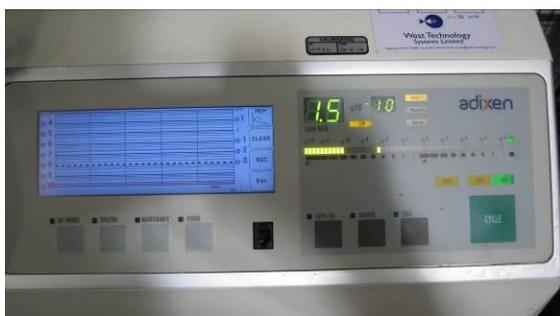
Figure 17: Helium leak rate
