SHORELINE EROSION AND IMPACT TO CABLE PROTECTION

Thomas E. Schaefer Jr. (TE SubCom), David Blau (TE SubCom), Ana Chamon (TE SubCom), Agustin Gutierrez Arroyo (Telefónica Global Solutions)
Email: teschaefer@subcom.com

Tyco Electronics Subsea Communications LLC.
250 Industrial Way West, Eatontown, NJ 07724 USA

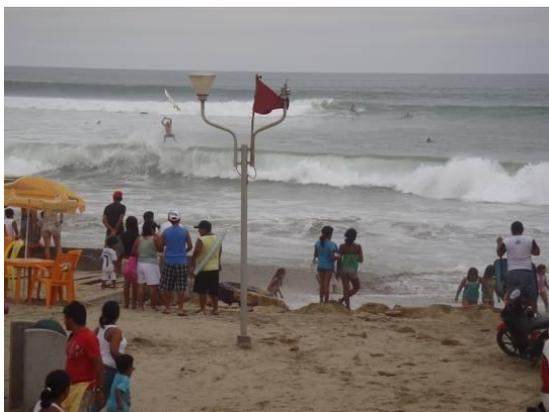
This appeared to be the situation in a case study location in South America. The location has been a very popular surfing destination for many years. (Figure 1). During storm conditions plunging breakers are constant and dramatic, greatly changing the beach profile.

Figure 1: Plunging Breakers

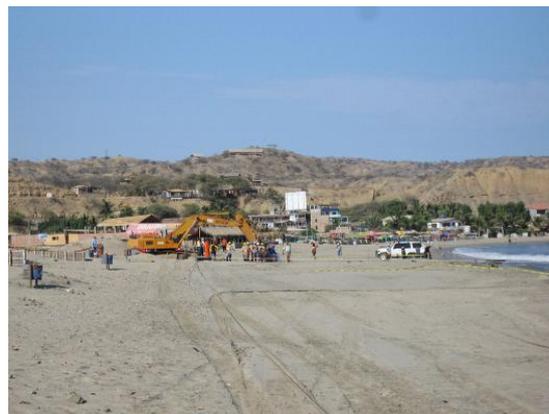
The Beach Manhole (BMH) was located 79 meters landward of mean low water in an area of low vegetation and adjacent to a local hotel. (Figure 2)

Figure 2: Landing Site 2007 prior to development

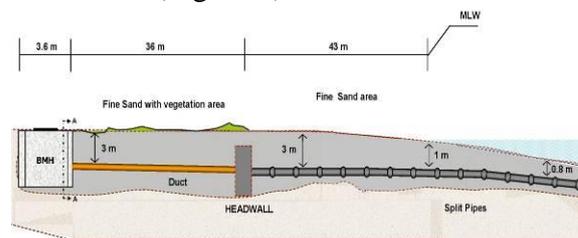
There were existing conduits from the BMH to a small anchor block located 36m seaward of the BMH. After the cable was landed, split pipe was applied to the cable to a position well offshore. The cable was then buried to 3m below grade, transitioning to 1m below grade at mean low water. (Figure 3)

Figure 3: Initial conduit and split pipe installation

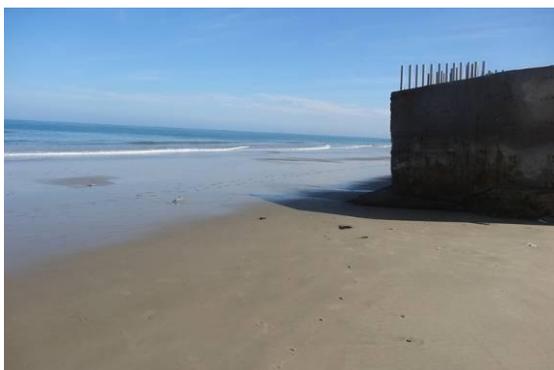
As the beach continued to recede, property owners constructed cement walls and filled sandbags in an effort to protect their property from the continued erosion due to wave action and transport of covering sediment. (Figure 5)

While some of these efforts seemed to provide temporary relief, the majority did not and some accelerated the erosion process. Sand bags were washed out to sea and vertical seawalls reflected the waves accelerating the erosion of the foreshore and at the ends of the seawall.

Figure 5: Vertical seawall reflects wave energy but does not dissipate, exacerbating erosion
