RE-USE AND RE-ROUTING OF RETIRING SYSTEMS

Abstract: Over the last few years there has been an increasing interest in recycling the components of retiring systems, to provide telecom traffic over a new route. As these new routes may not warrant the cost of purchasing a completely new system, the recovery and re-installation of a retiring system may provide a more cost effective solution. The challenges of recovery and relaying a retiring system along a new route are discussed. The associated testing and commissioning requirements are also examined. Whilst the standard system life design is for 25 years, other equipment and software has a shorter life, as such, re-engineering maybe required to replace obsolete equipment. The consequences of dismantling and the reassembly of equipment are considered. Operation and Maintenance of re-furnished systems is an important consideration as skilled people are required for installation, testing and training. Finally, the parameters and conditions required from both the donor system and new route are discussed so that any future system-recycling program can be evaluated objectively.

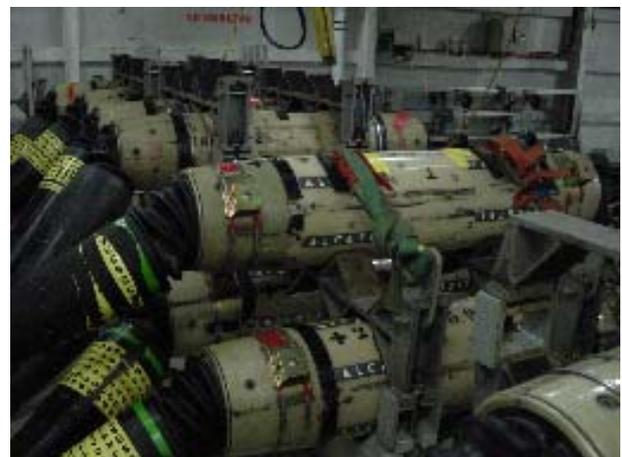
Figure 2: Recovered Repeaters

It is worth noting that, despite lying on the seabed for 10years, the recovered cable and repeaters were in pristine condition - almost as though straight from the factory [figure 2 and figure 3].
