CABLE PROTECTION METHODOLOGY AT SURF ZONE IN MALDIVES

Naoki Maekawa, Mikinori Niino, Yutaka Kiuchi (NEC Corporation)

Abstract: NEC was contracted for the turn-key supply of a submarine cable system for a customer in the island nation of the Maldives. This paper describes the cable protection methods used in the completion of the cable system, which would be useful for future projects in similar environments.

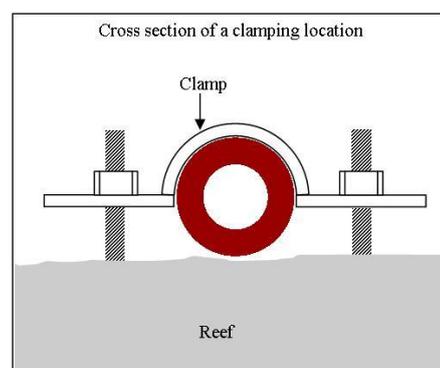
Figure-1 Clamp and Anchor Bolts

It is best to clamp for all pieces of Articulated Pipe on to seabed however in that case the number of the clamps required will be an unrealistic amount and the material cost and installation duration were not allowed for the project schedule. Permissible range of the clamp amount for the project was calculated as every 10m intervals.

The concern was that there will be 20 joints within 10m of Articulated Pipes. Each joint shall be designed to have “play” for adjusting to install along the cable route.

The clamps with 10m intervals was expected just to reduce the movement of Articulated Pipe and the abrasion risk caused by the movement of Articulated Pipe remains.

In order to reduce the movement that shall cause abrasion of Articulated Pipe, fixing the Articulated Pipe onto seabed with the clamp shall be effective.

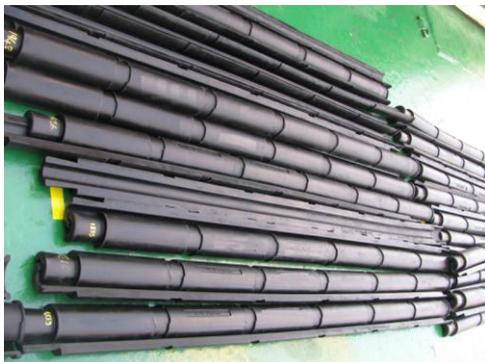
Photo-3 Typical Polyurethane Duct

Polyurethane is unbreakable elastomer. It is expected that Polyurethane Duct provides the higher protection performance against abrasion and impact compared with cast iron pipe.

The countermeasure against abrasion which can not avoid with clamps of 10m intervals was to change the material of Articulated Pipe from the cast iron to Polyurethane.

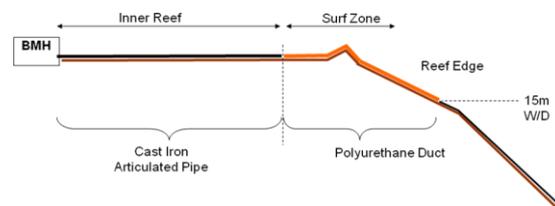
Figure-2 Protection Diagram

Usually unit cost of Polyurethane Duct is higher than Articulated Pipe. In order to reduce the cost impact of changing material, detailed diver swim surveys were carried out around surf zone each sites. The purpose of the survey is to confirm the actual condition of the sites. As the result of the diver swim survey, the areas inshore side of the surf zone were relatively stable condition and it was assumed that there were less risk of abrasion damage then it was decided that Polyurethane Duct would only be adopted on and offshore side of the surf zone.
