RE-INSTALLATION OF RECOVERED SUBMARINE CABLES; CASE HISTORIES OF SUCCESS

Tyco Telecommunications (US) Inc.

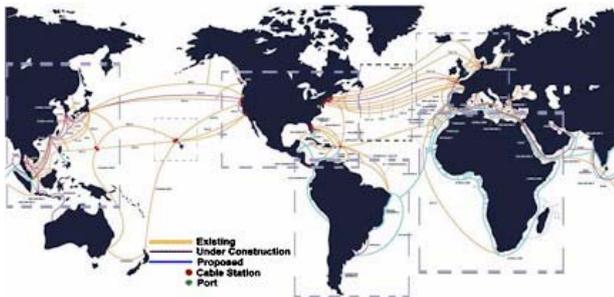
Fig. 1. Location of the World's Submarine Cables

The table indicates that there is a large amount of de-commissioned fibre optic cable lying on the seabed throughout the world, but an important parameter is the location of a desired cable relative to the area of commercial or scientific interest. Figure 1 below shows the distribution of the submarine telecommunications systems throughout the globe, both in-service and de-commissioned:

One factor in estimating the cost of a commercial or scientific submarine cable system is its location with reference to the de-commissioned cable to be recovered. The distribution of cables shown in Fig. 1 above shows that although there is a large amount of usable fiber optic cable on the seabed, the majority of cable lies in the northern hemisphere.

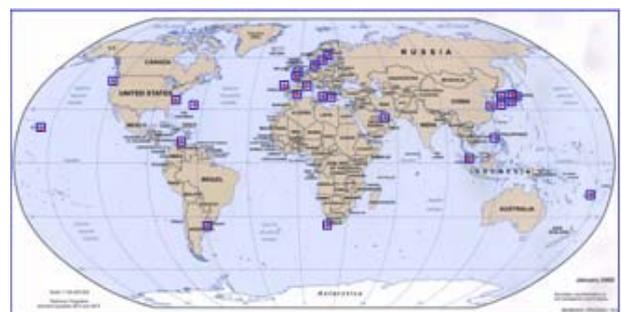
Fig. 2 Location of Cables Incl. Maintenance Ships

Figure 2 below illustrates the general disposition of cables around the globe, which, naturally, correspond to the main cable routes:

From Table 3 and Fig.2, it can be seen that there are suitable cables positioned worldwide, but care must be taken in ascertaining their suitability for the additional specific tasks involved in the recovery and
